How to remove side cover in order to remove spark gap

Spark Gap Cleaning Process

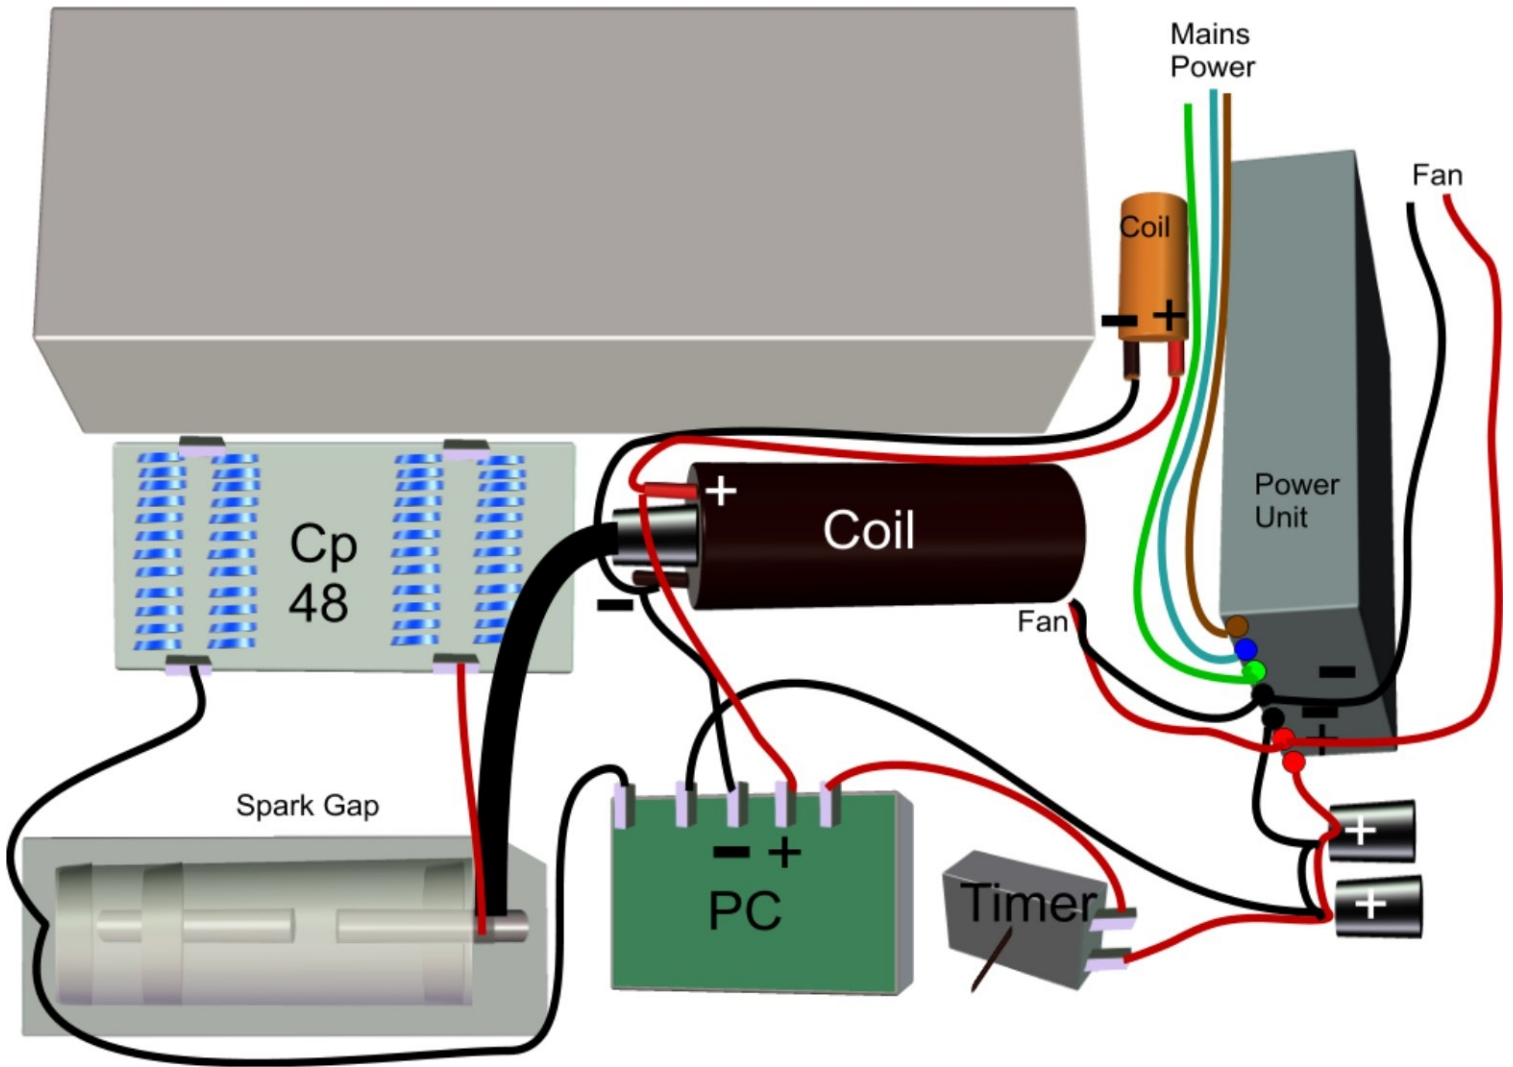
**Spark Gap
Adjusting knobs**

**Spark Gap
Viewer**

Vents

Timer

Spark Gap

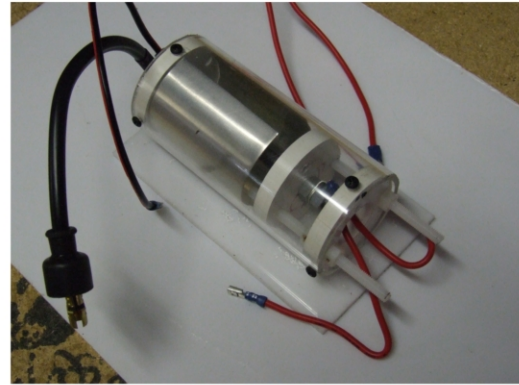
This is the spark gap, as you can see there is end 1 and end 2. When re-assembling these ends must be inserted back into the same ends of cylinder they were taken out of.

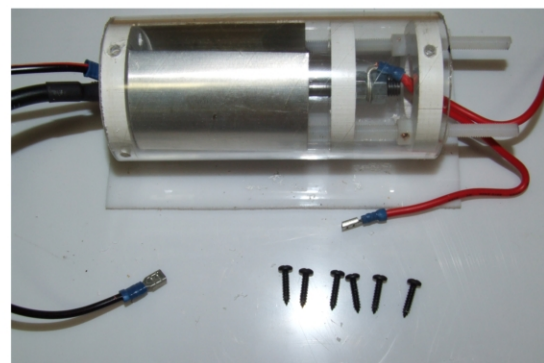
When screws are removed as seen above ,please proceed to page 2.

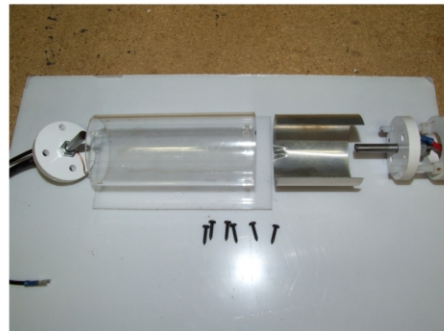
When finished this is what you should have.

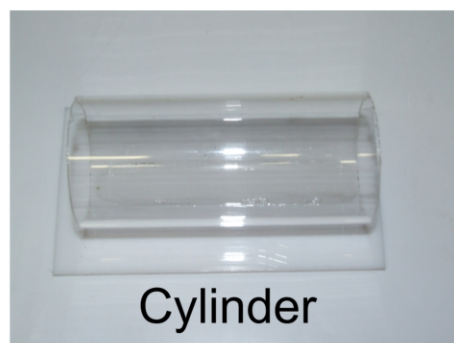
Clean the cylinder with warm soapy water and dry off thoroughly (do not use cold water or hot water as this will crack the cylinder)

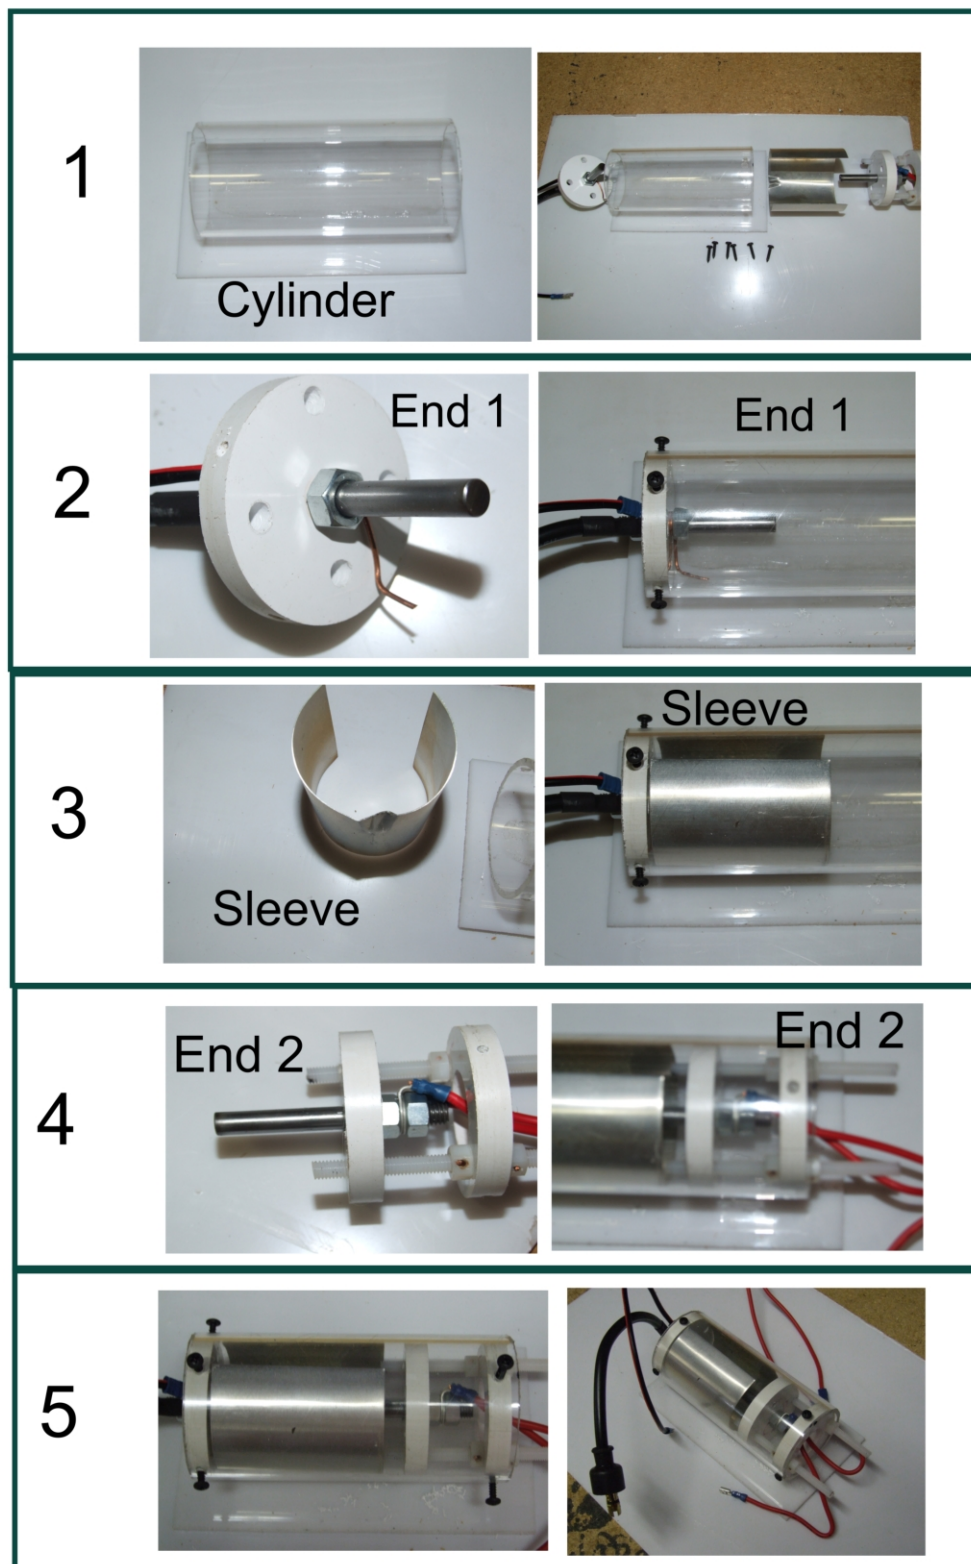
Re-assembling of the Spark Gap

Follow these steps below
