# Spark Gap

# Spark Gap Cleaning Process

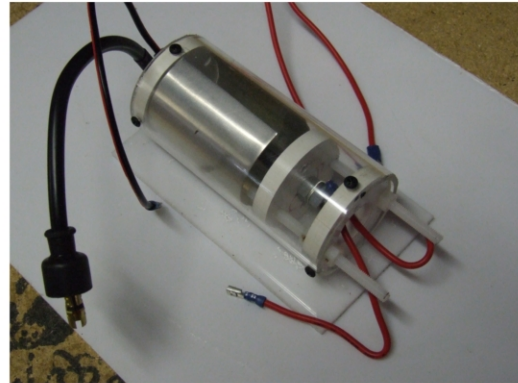
This is the spark gap, as you can see there is end 1 and end 2. When re-assembling these ends must be inserted back into the same ends of cylinder they were taken out of.

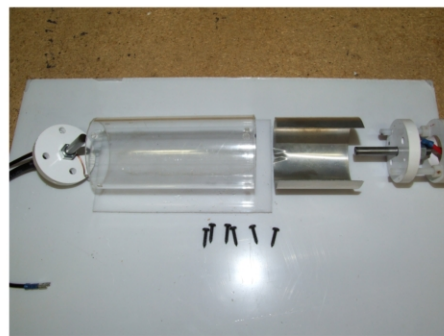
When finished this is what you should have.

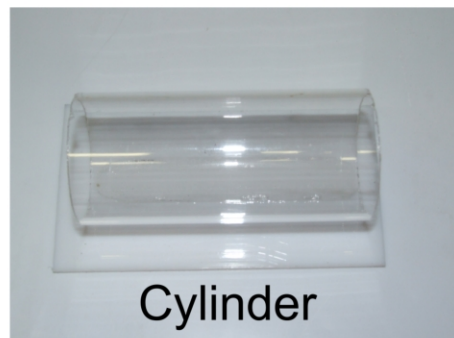
Clean the cylinder with warm soapy water and dry off thoroughly (do not use cold water or hot water as this will crack the cylinder)
