MWO Spark Gap Cleaning Instructions

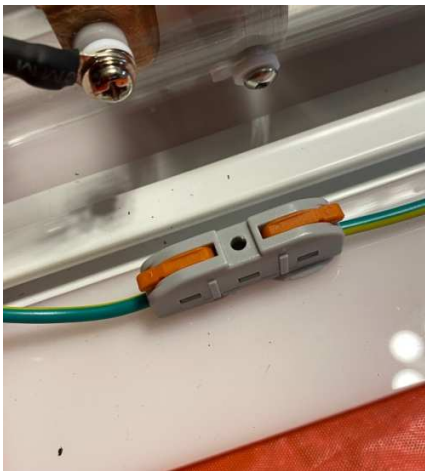
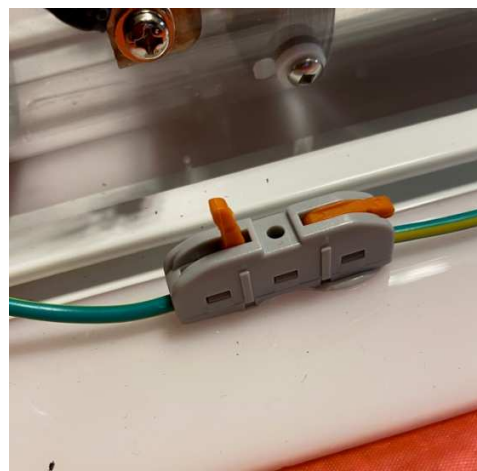
1. Once you have removed the left side panel, unclip the cable from the cable connector at the front of the unit. Lift the orange lever tag (as shown above). The cable will slide out freely.

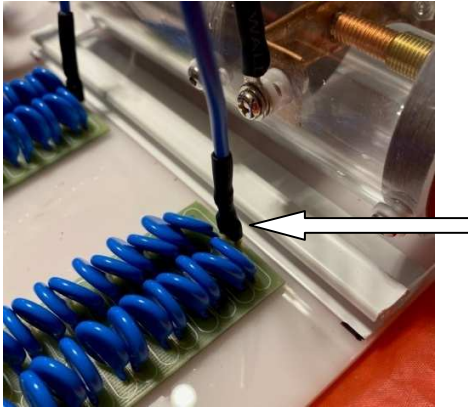
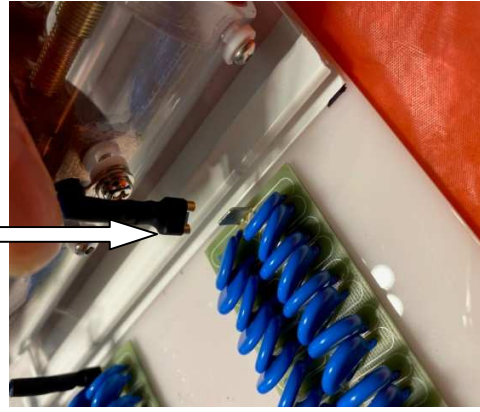
2. Remove the spade clip from the capacitor board and the second spade clip from the second capacity board behind this (as seen in the picture above). Only remove these 2 clips.

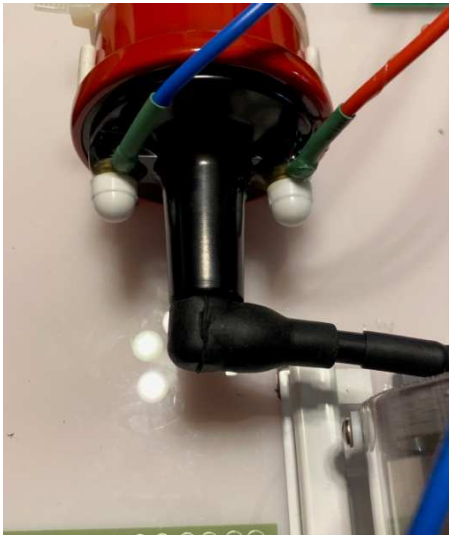
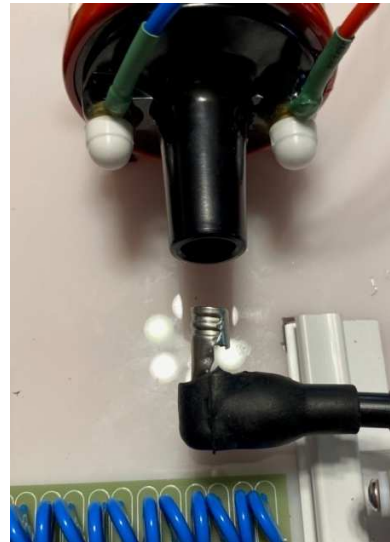
3. Finally, remove the coil plug from the red coil. This clips in firmly and should be refitted the same way. Once all 3 connections are removed, the complete spark gap assembly will slide out easily for cleaning.
